# Debris/Ice/TPS Assessment and Integrated Photographic Analysis for Shuttle Mission STS-54

(NASA-TM-107558) DEBRIS/ICE/TPS  
ASSESSMENT AND INTEGRATED  
PHOTOGRAPHIC ANALYSIS FOR SHUTTLE  
MISSION STS-54 Final Report, 12-21  
Jan. 1993 (NASA) 146 p

DEBRIS/ICE/TPS ASSESSMENT  
AND  
PHOTOGRAPHIC ANALYSIS  
OF  
SHUTTLE MISSION STS-54

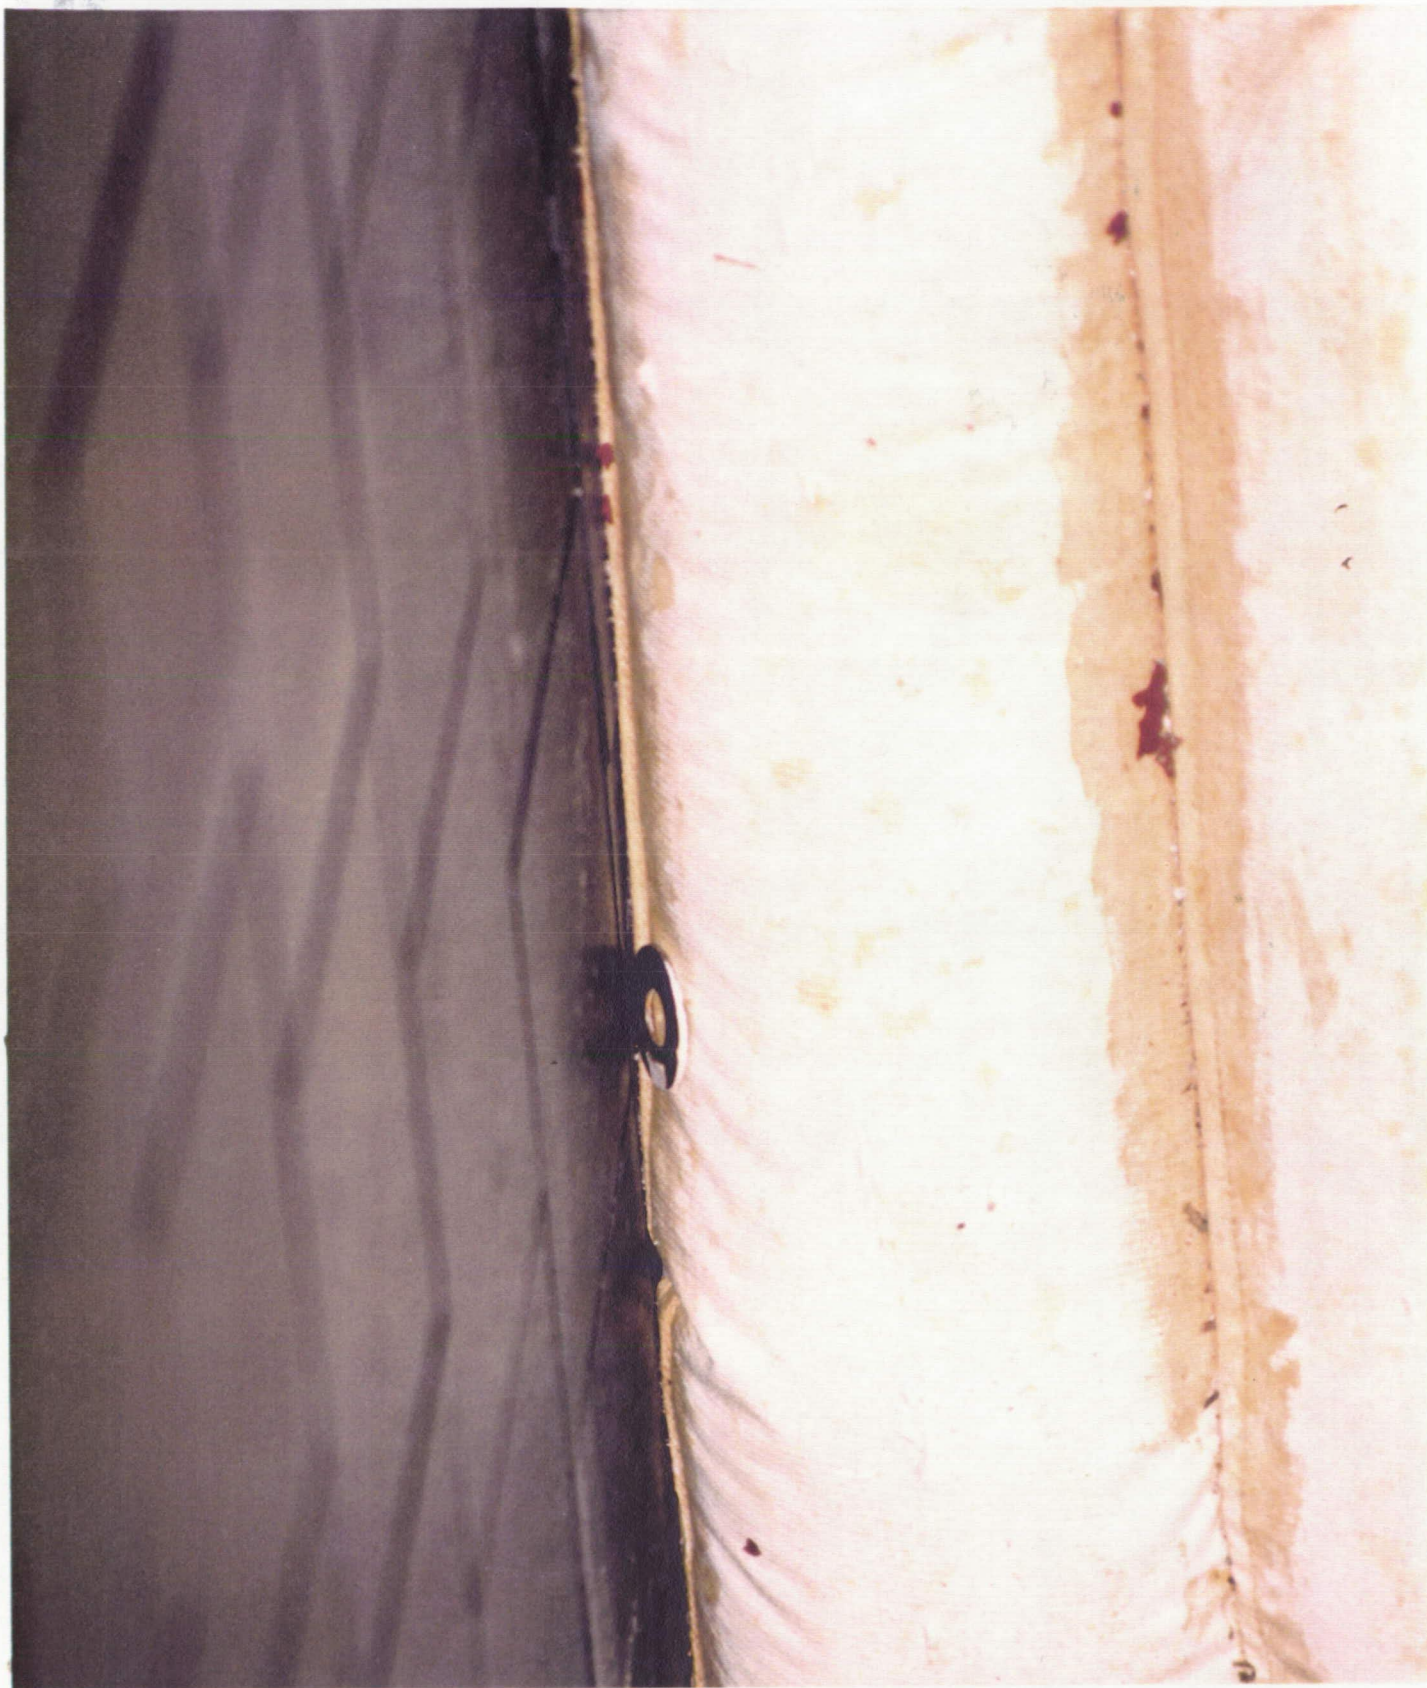
A metal washer lay against Orbiter tiles on top of the Orbiter Access Arm inflated seal. After removal, a partial coating of white paint was found on the washer similar to that covering the nearby hypergolic fuel system access platform. No damage to Orbiter tiles was detected.

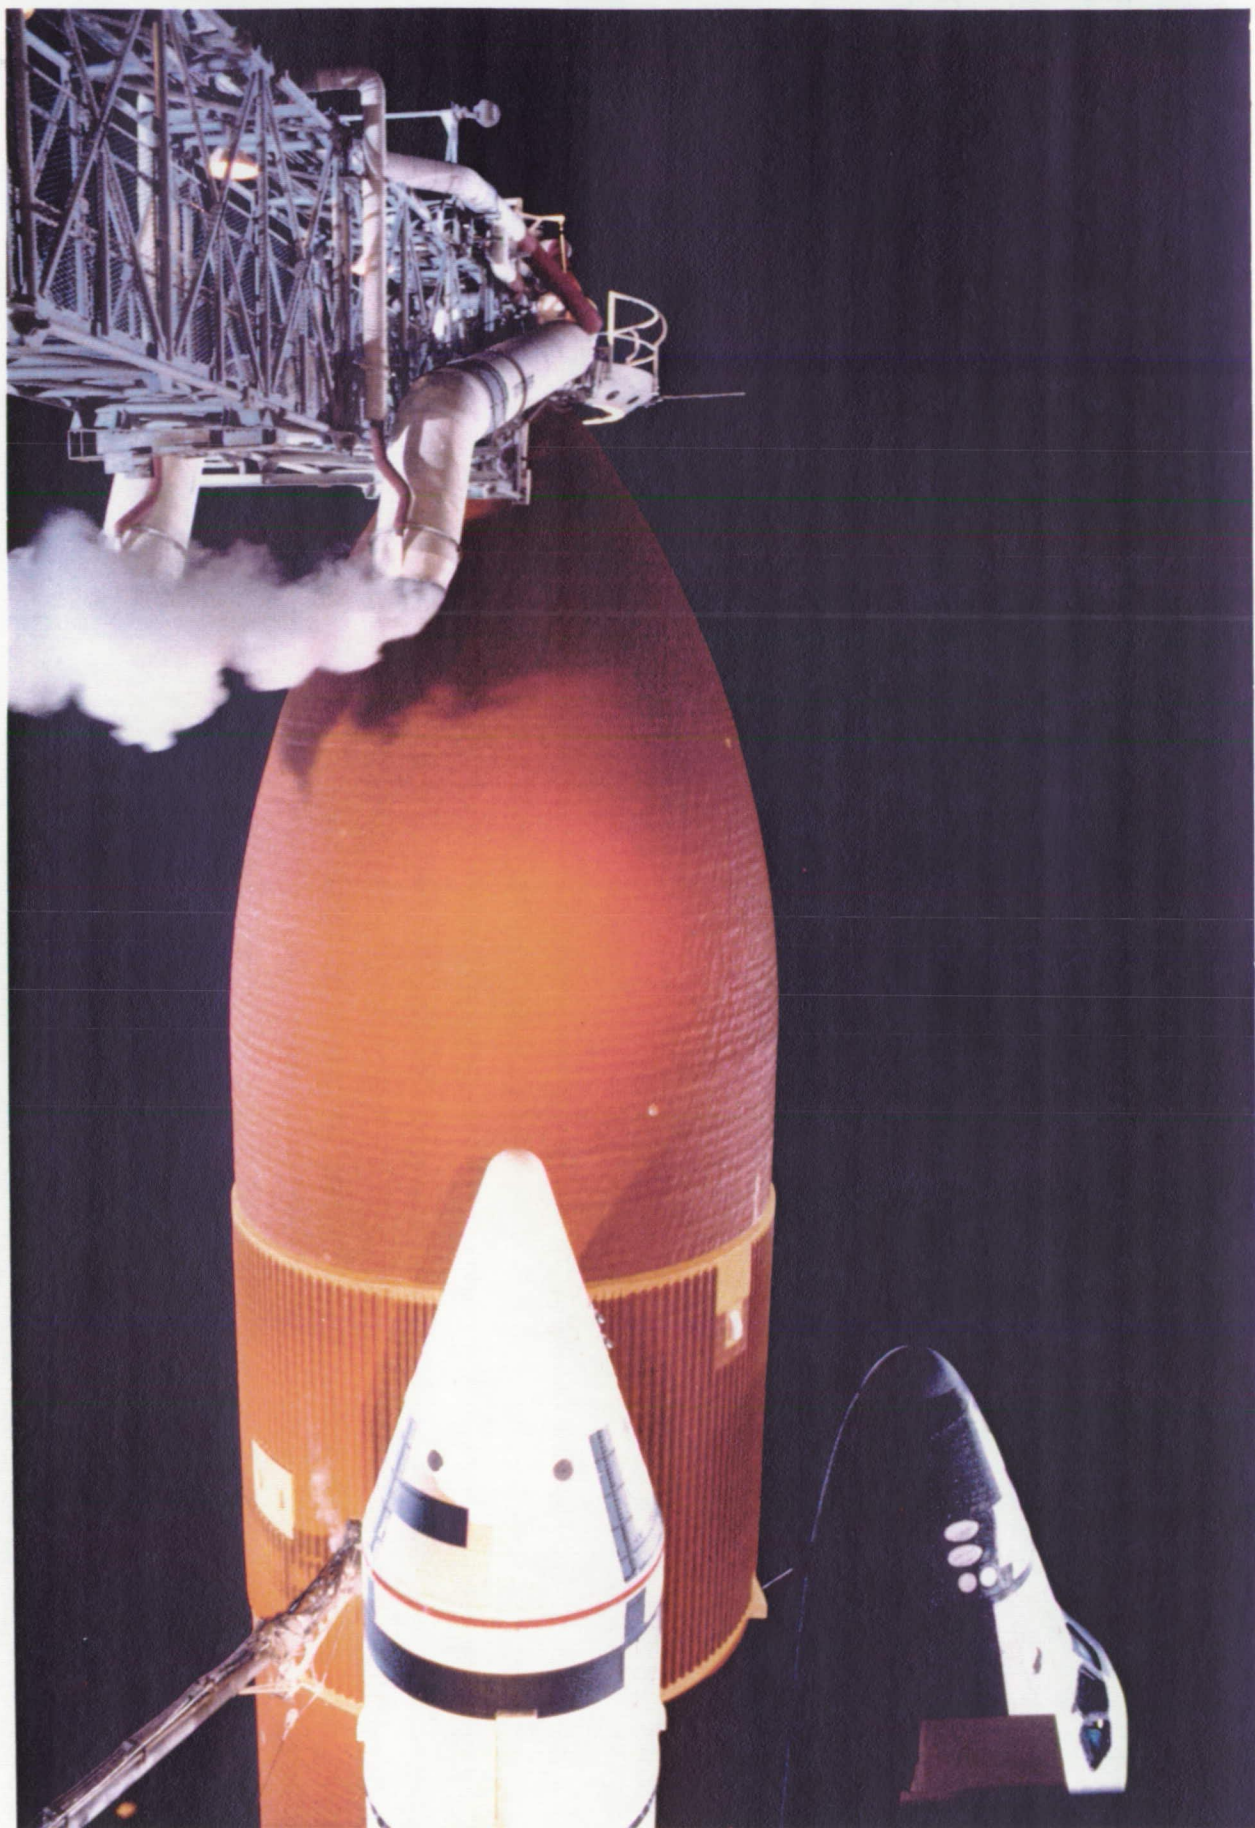
There were no TPS anomalies or ice/frost accumulations on the L02 tank. Some light condensate was present on the L02 tank barrel section.

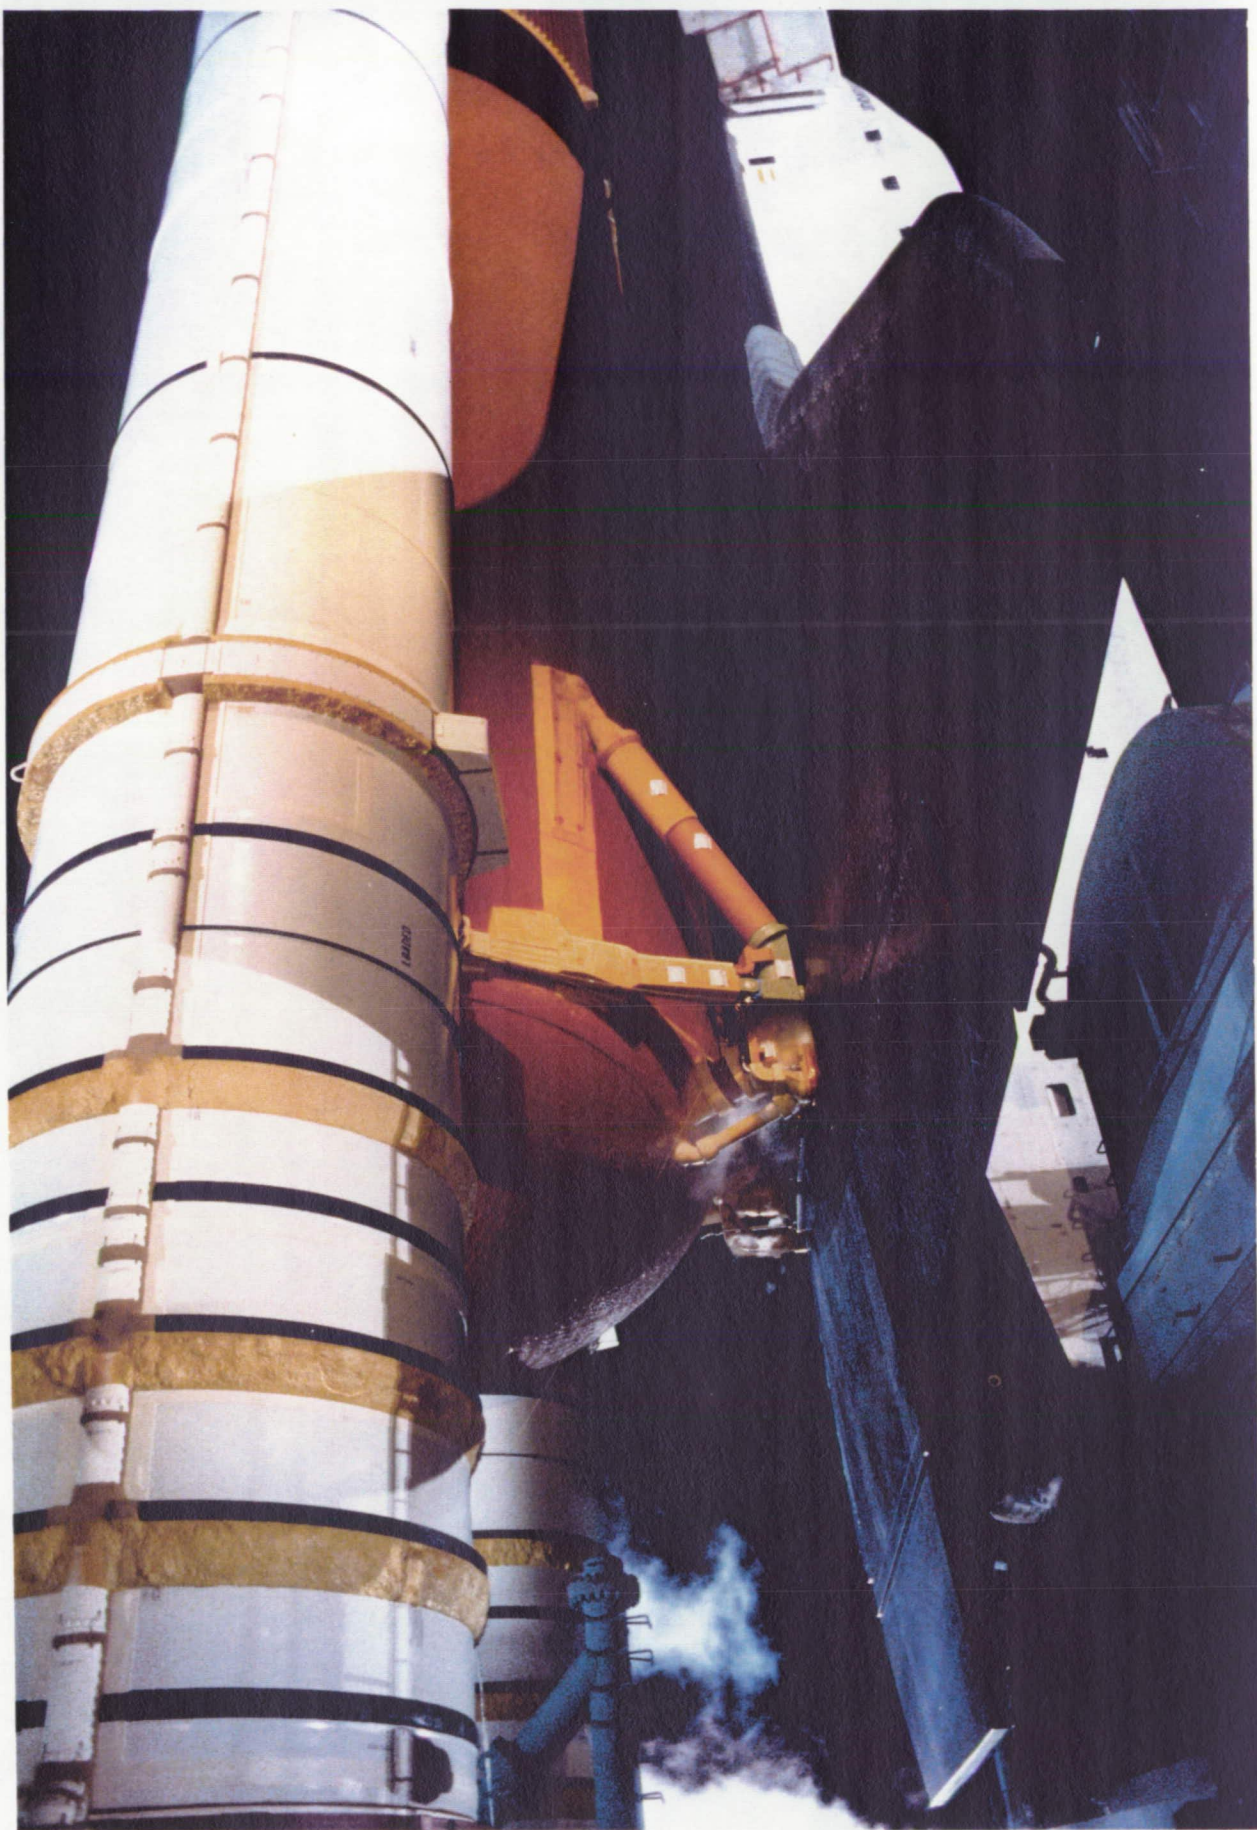
There were no LH2 tank TPS acreage anomalies. Light condensate, but no ice or frost, was present on the acreage and aft dome.

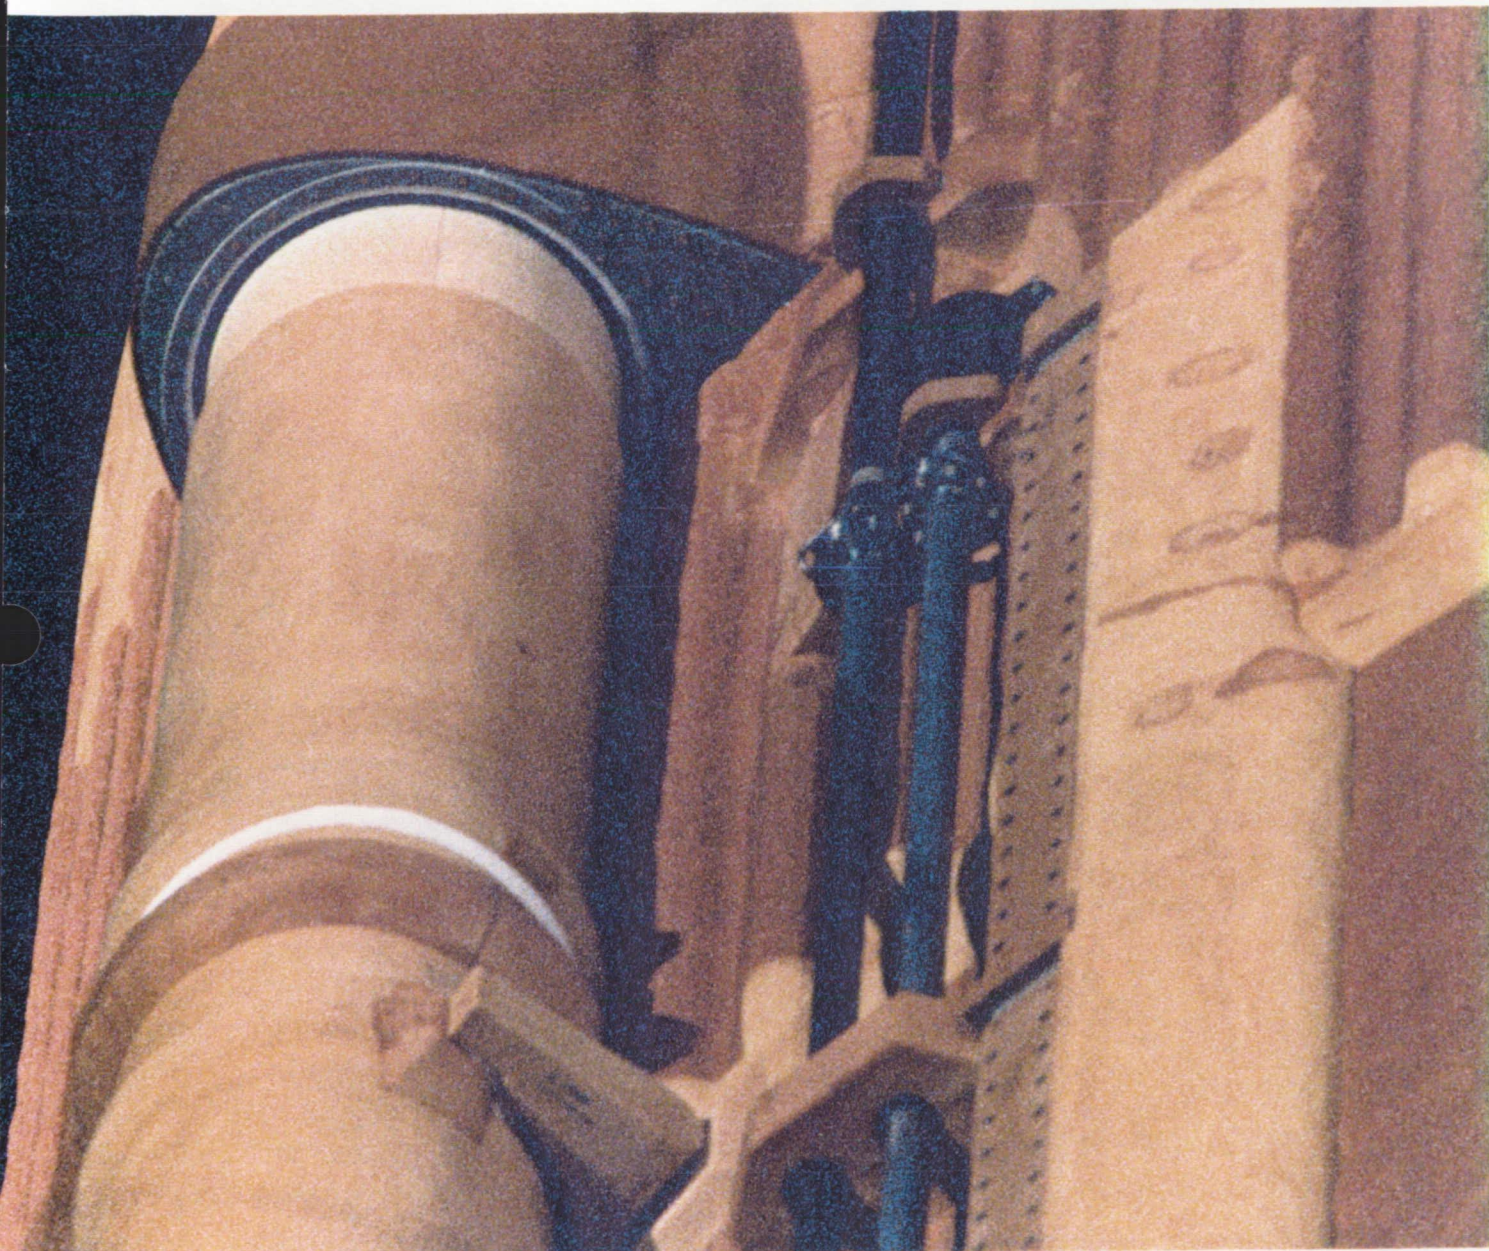
Typical amounts of ice/frost were present in the LO2 feedline  
upper bellows and support brackets

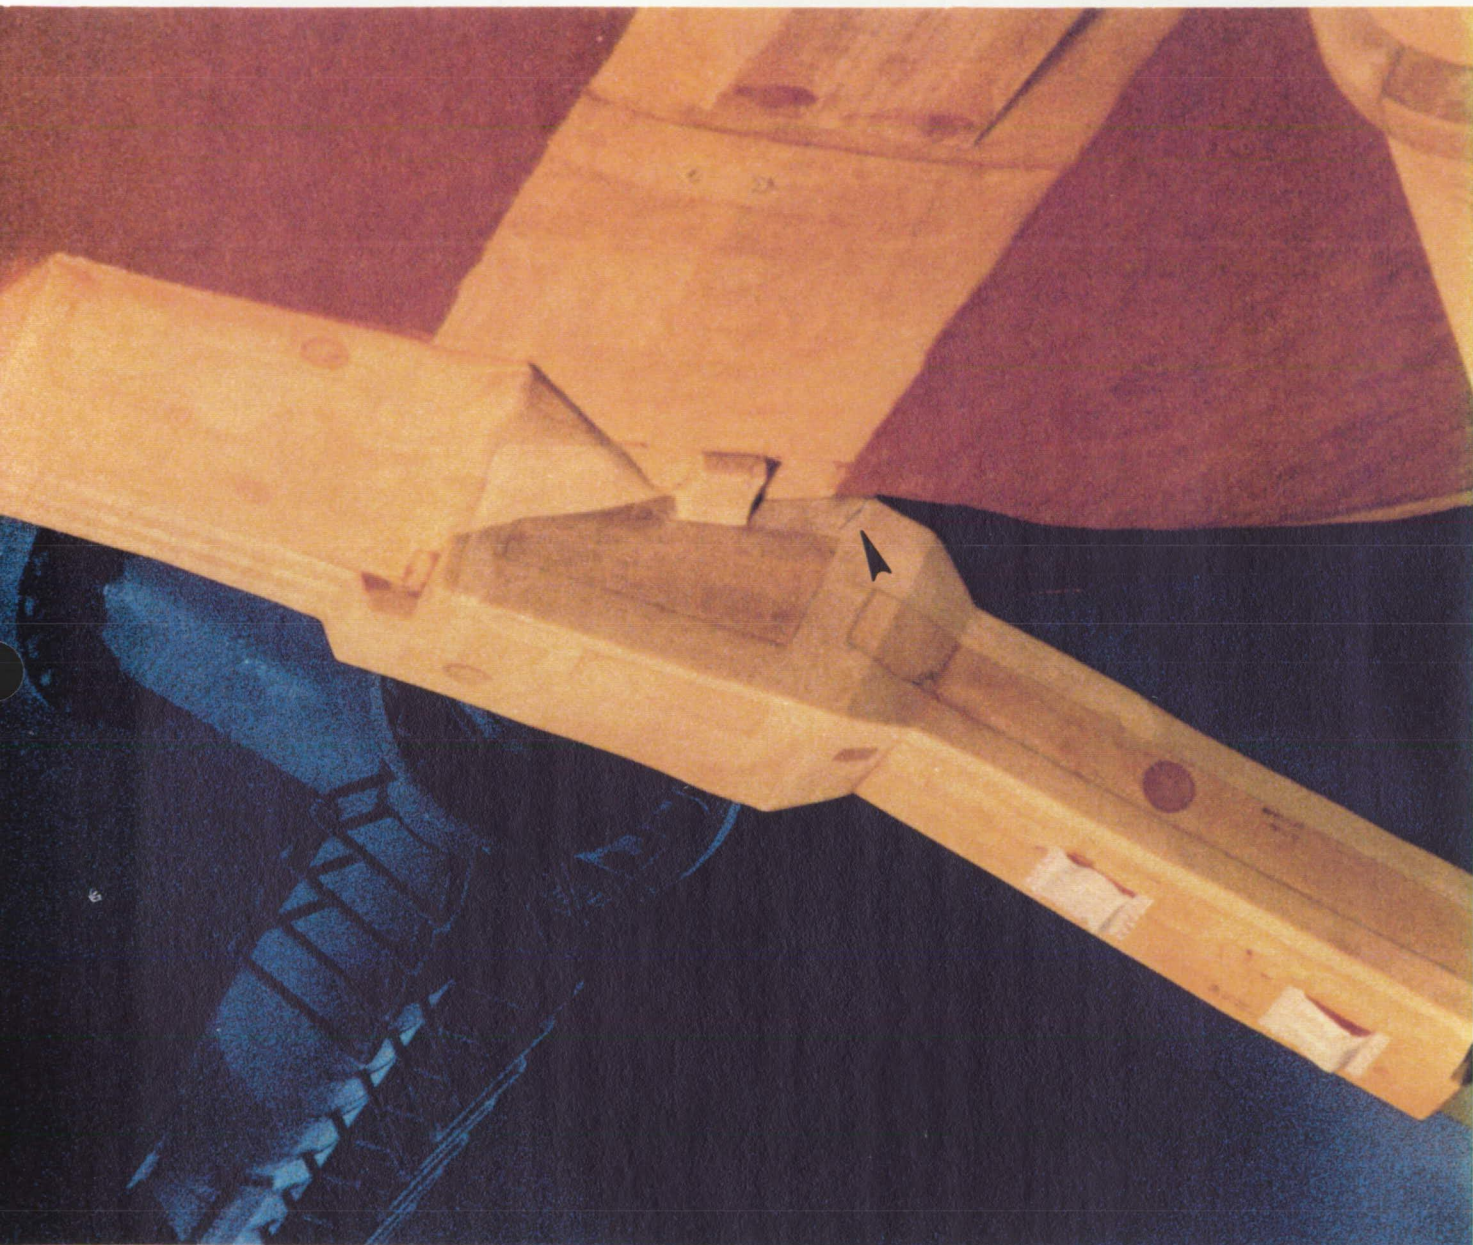
A 4-inch long crack was present in the -Y vertical strut cable tray forward surface TPS near the longeron closeout interface. The 1/4-inch wide crack exhibited no offset and was not filled with ice or frost. The appearance of the crack was expected due to the elimination of the stress relief gap at the factory.

A 4-inch long crack was present in the -Y vertical strut cable tray forward surface TPS near the longeron closeout interface. The 1/4-inch wide crack exhibited no offset and was not filled with ice or frost. The condition was acceptable for flight.

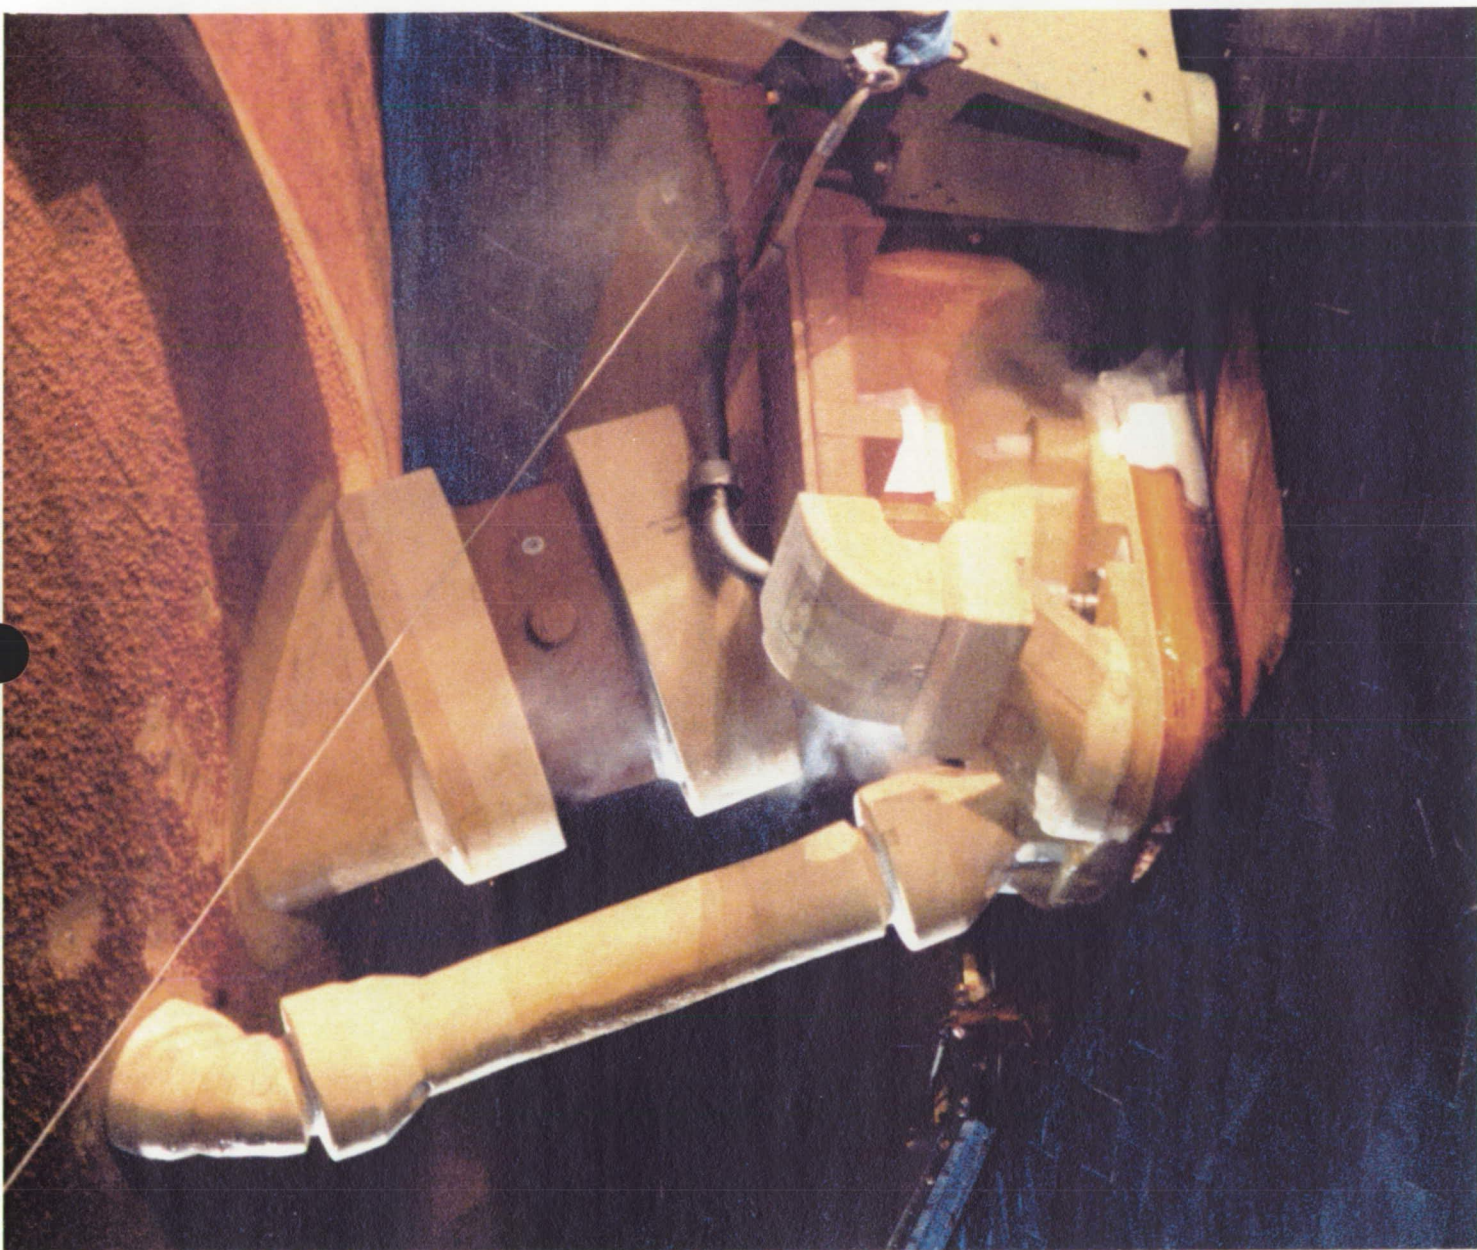
Ice/frost formations on the ET/ORB LH2 umbilical were typical. No unusual vapors or cryogenic drips had appeared during tanking, stable replenish, and launch.

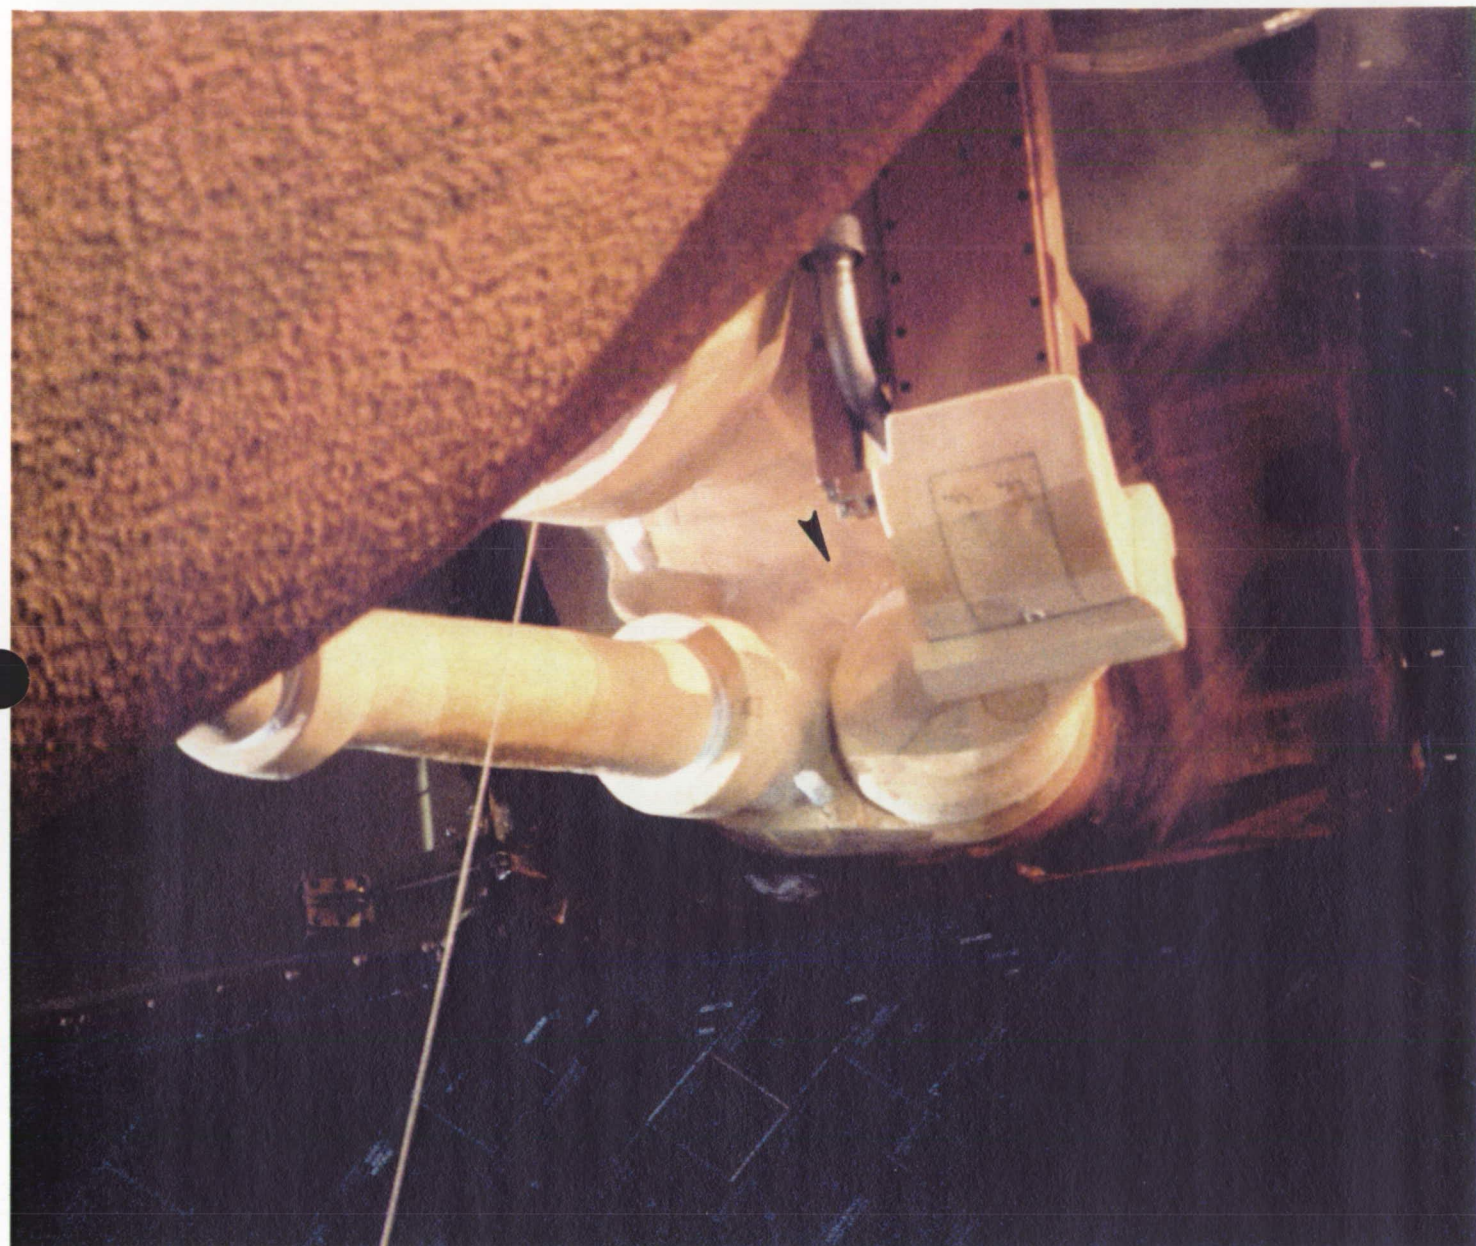
Typical in size, ice/frost fingers had formed on the aft plate gap purge vent and LH2 umbilical cable tray vent hole. No ice or frost had formed on the 17-inch flapper valve actuator access port TPS plug closeout indicating a proper closeout.

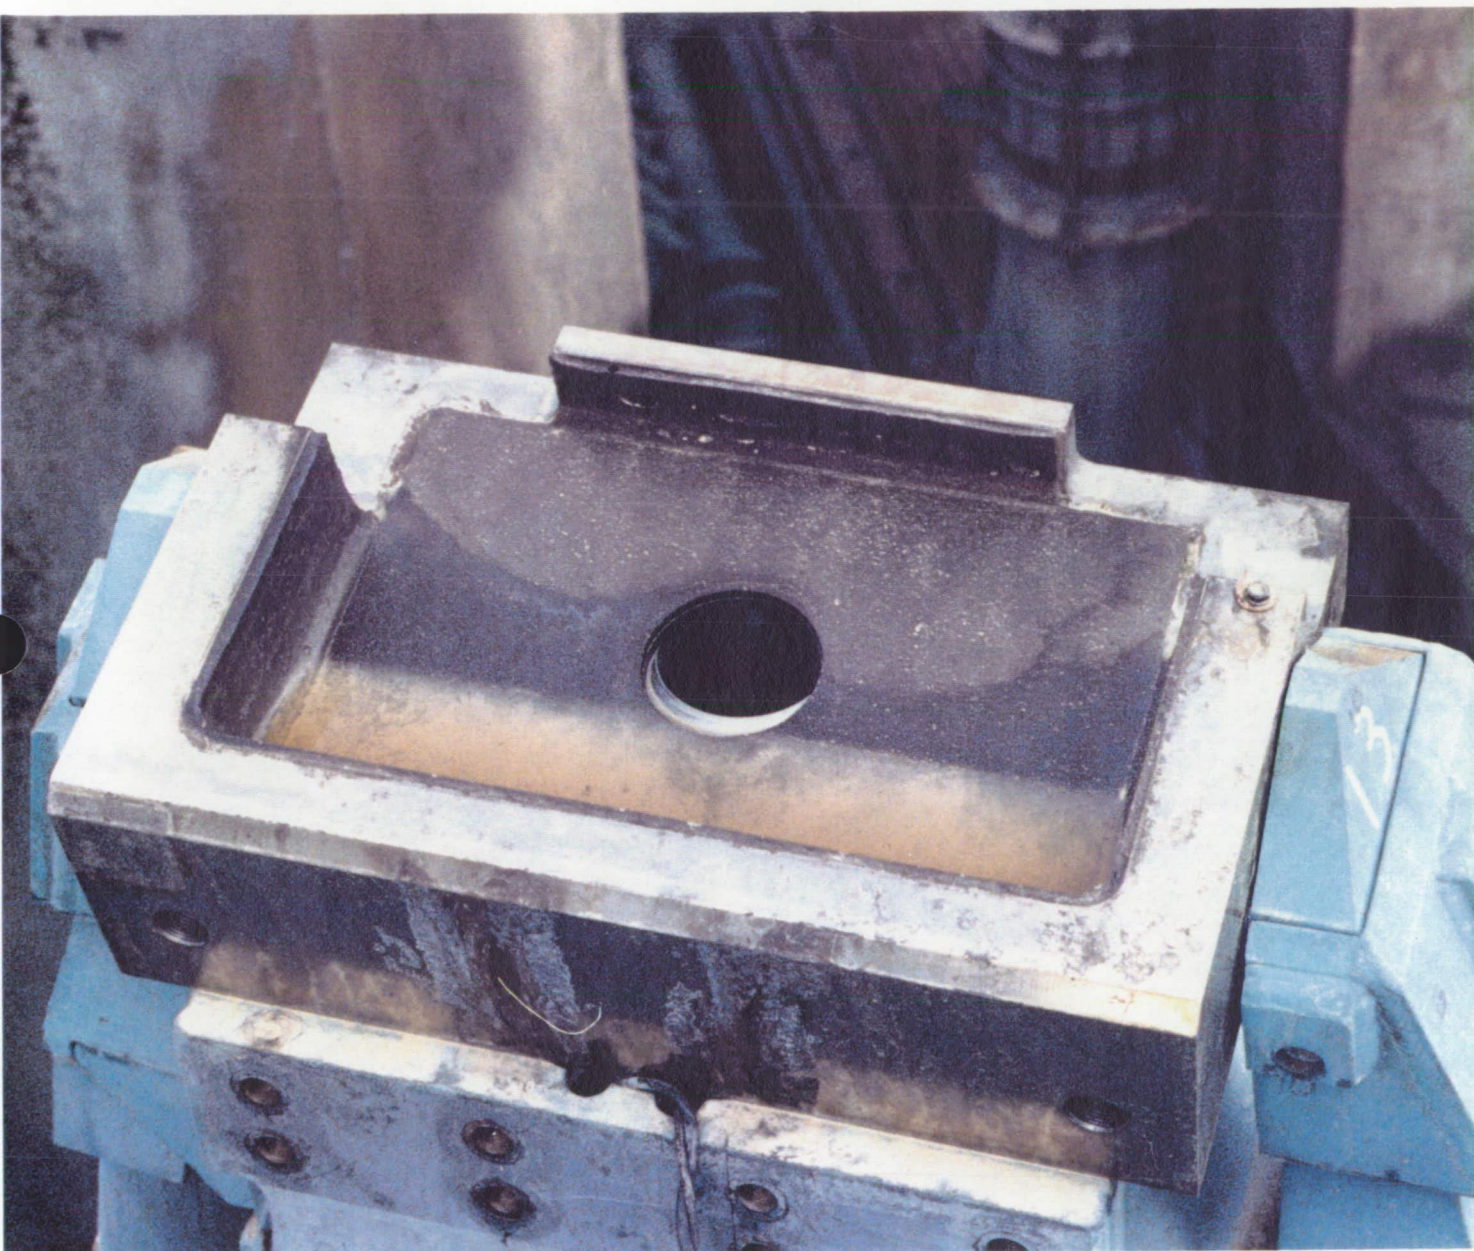
Plume erosion of the south SRB holddown posts was typical. EPON shim material was intact but slightly debonded from the sidewalls of the holddown post shoes.

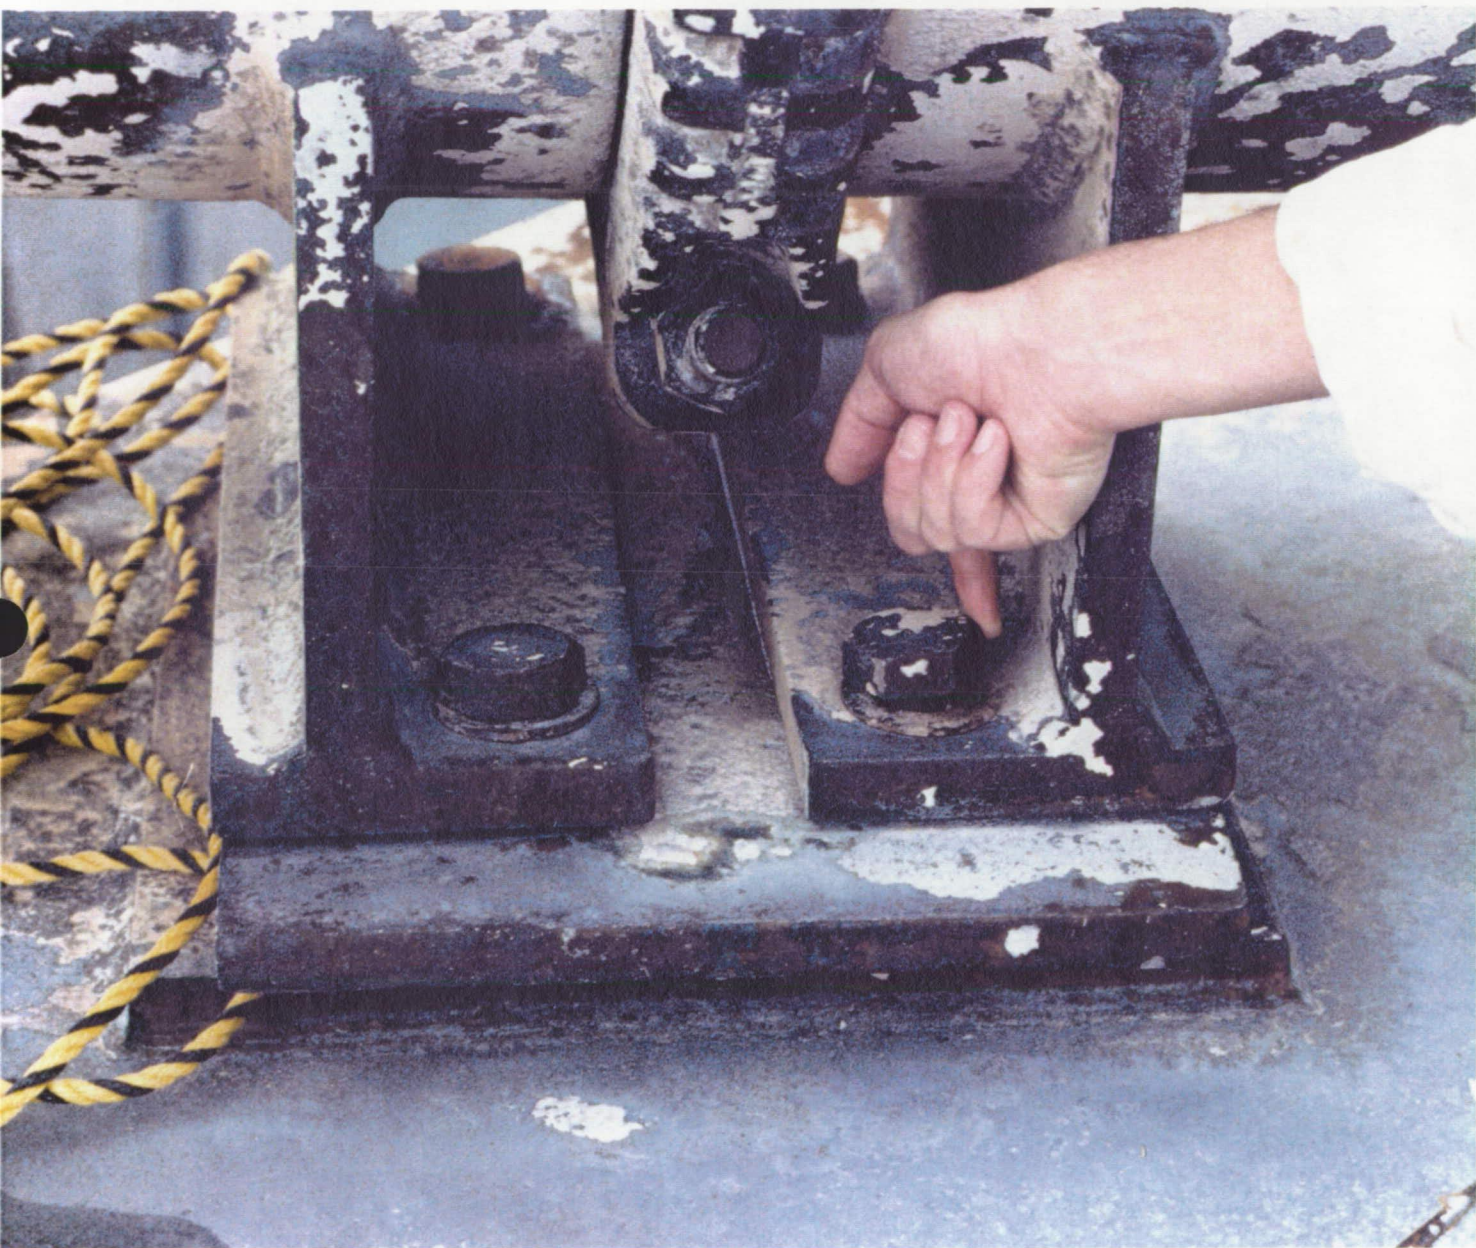
A sound suppression pipe base mounting plate bolt  
north of the RH SRB exhaust hole was loose

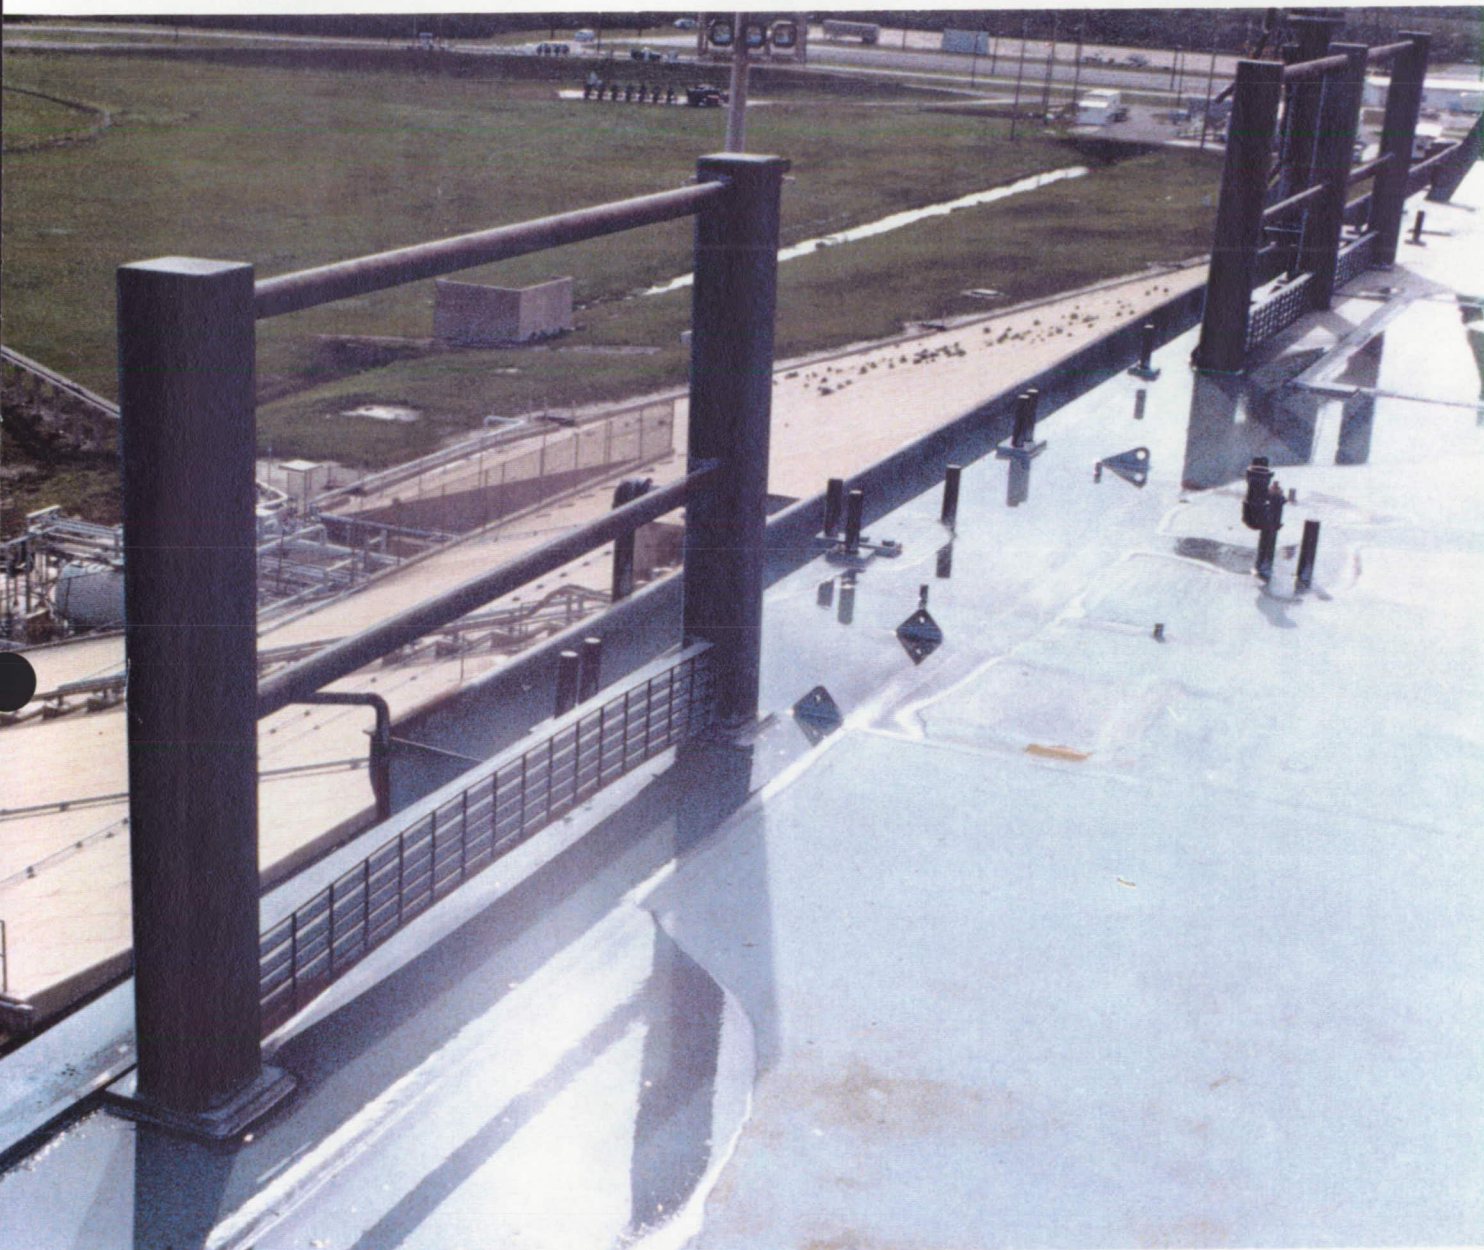
The seven test sections of the permanent MLP deck perimeter handrails were generally in good shape after launch except for the east and west side removable sections, which exhibited minor deformation of the kickplates.

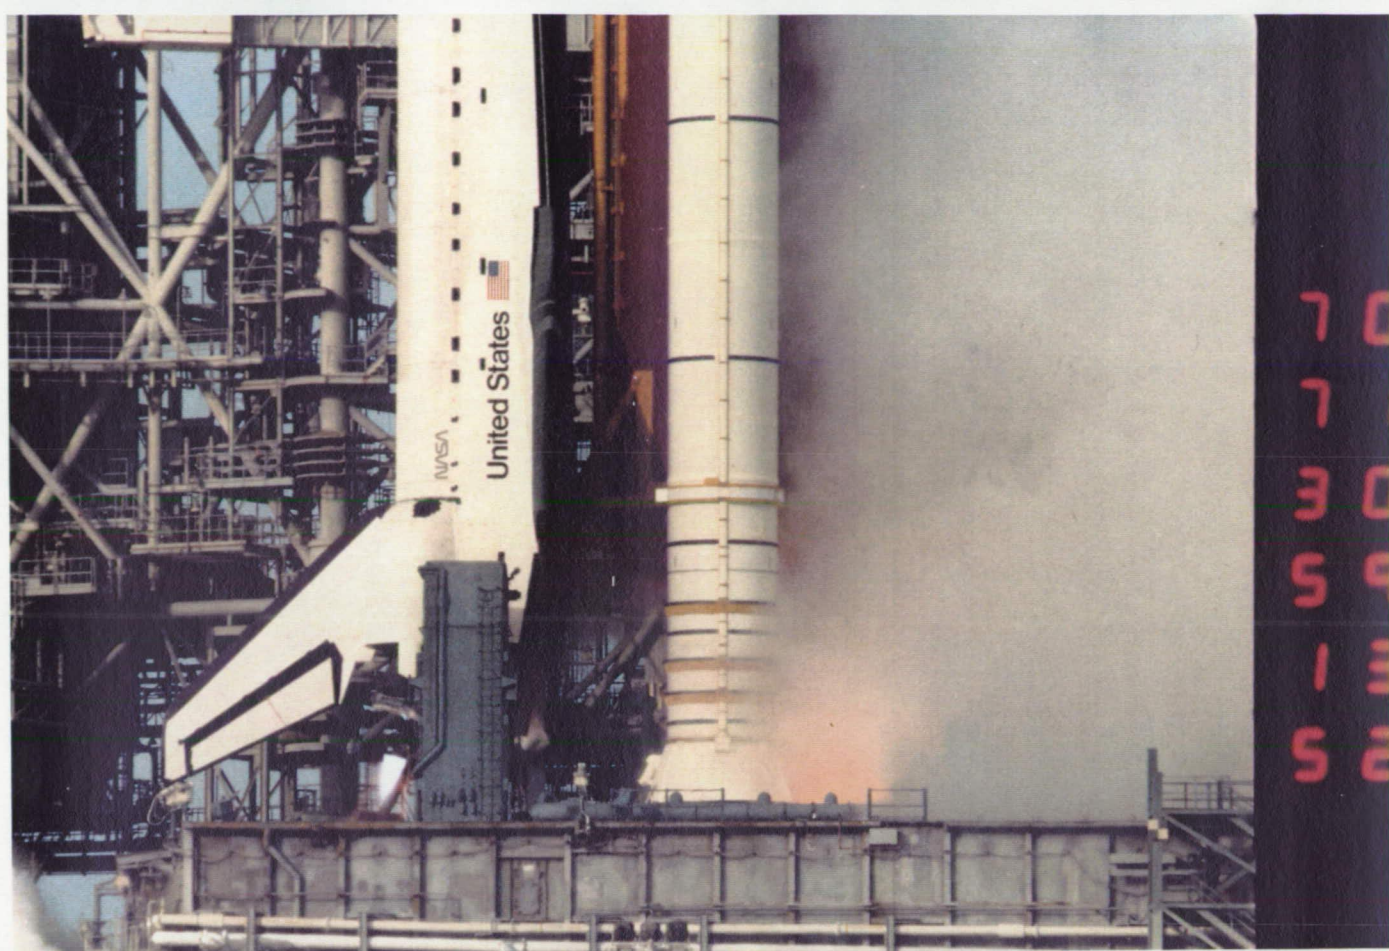
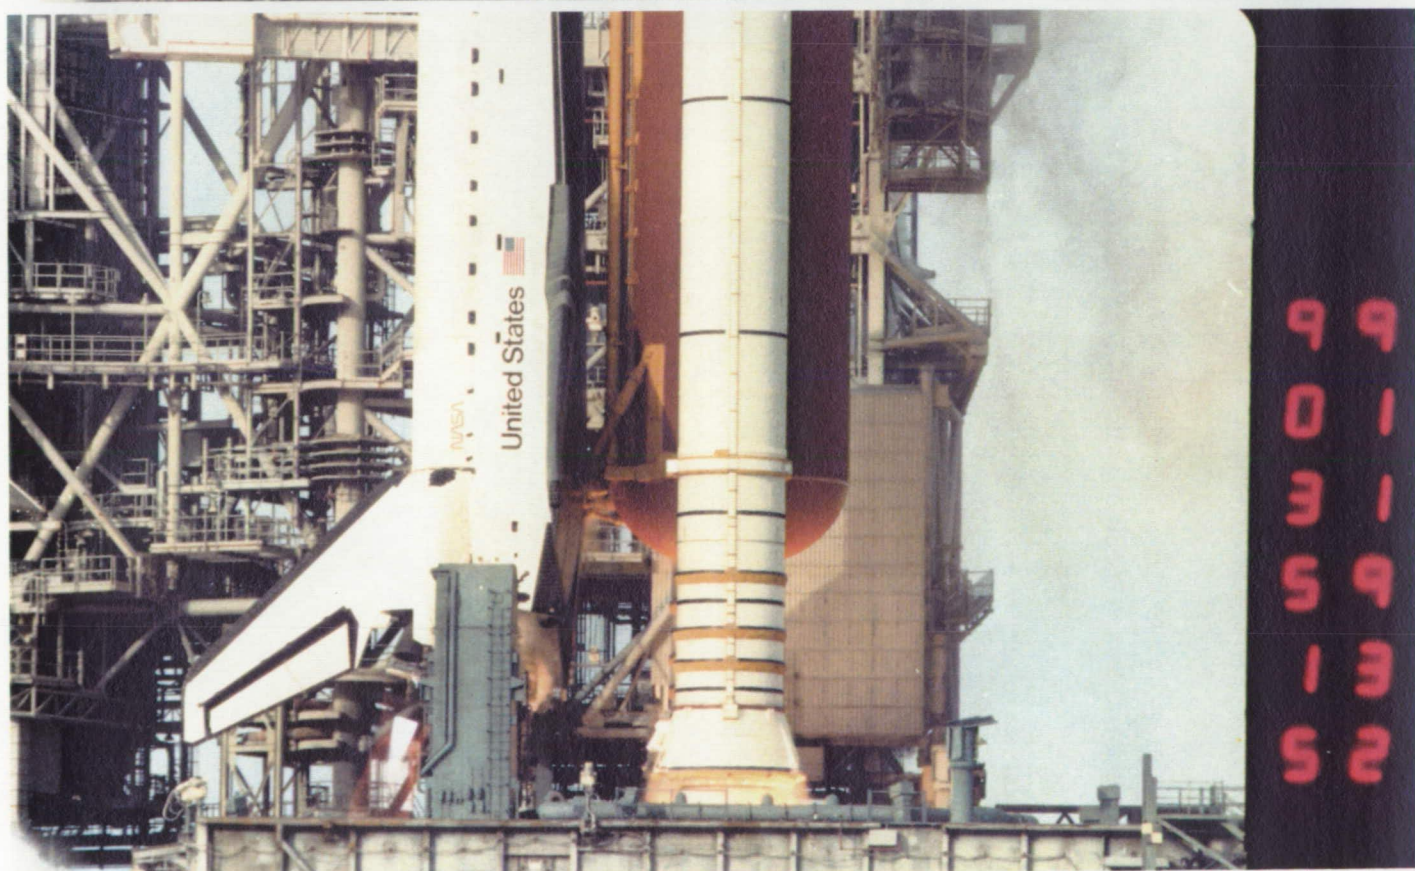
A brown-colored object, 6 inches long by 1 inch wide, appeared in the body flap hinge area and fell aft during SSME ignition. The object is believed to be a brown GSE tile shim, or spacer.
